GROUP	MODEL
ELE	See Model List
NUMBER	DATE
163	May 2019
	-

## TECHNICAL SERVICE BULLETIN

PARASITIC DRAW INSPECTION AND REAR DOOR LATCH REPLACEMENT

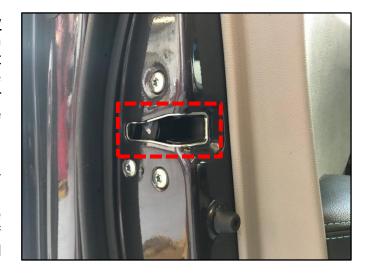
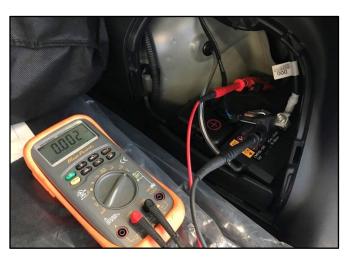
- 1. Open the front doors and manually close the front door latches.
- 2. If the 12v battery is located under the hood, leave the hood open and if applicable, disconnect the hood switch.
- 3. If the 12v battery is located in the trunk, leave the trunk open and manually close the trunk latch.
- 3. After the vehicle is in sleep mode, observe the connected ammeter for a few minutes.
  - If the current does not go over 50mA, reinstall the negative (-) battery terminal in the reverse order of removal. No further action is required. Verify customer's radio presets were retained or restore, if necessary, using recorded information in step 1.
  - If the current goes over 50mA, proceed to the next step.
- 4. Disconnect the left rear door harness behind the rubber grommet, located at the B-pillar.

Allow the vehicle to go back to sleep mode and then observe the ammeter for a few minutes.

- If the current does not go over 50mA, replace the left rear door latch by following the door latch replacement procedure on page 3.
- If the current goes over 50mA, proceed to the next step.

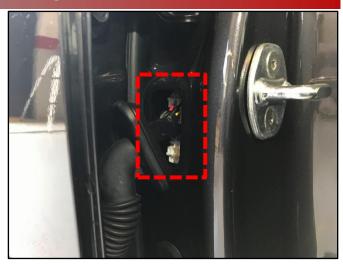
5. Disconnect the right rear door harness, located at the B-pillar.

Allow the vehicle to go back to sleep mode and then observe the ammeter for a few minutes.

- If the current does not go over 50mA, replace the right rear door latch by following the door latch replacement procedure on page 3.
- If the current goes over 50mA, further diagnosis or repair is required and not covered in this bulletin. File a separate claim if necessary.
